Review of Standardization of Parking Area Markings at Aji Pangeran Tumenggung Pranoto Airport, Samarinda

Sultan Aqilla Ahmad Napitupulu*, Hemi Pamuraharjo, Dini Wagini
Program Studi Operasi Bandar Udara, Politeknik Penerbangan Indonesia Curug

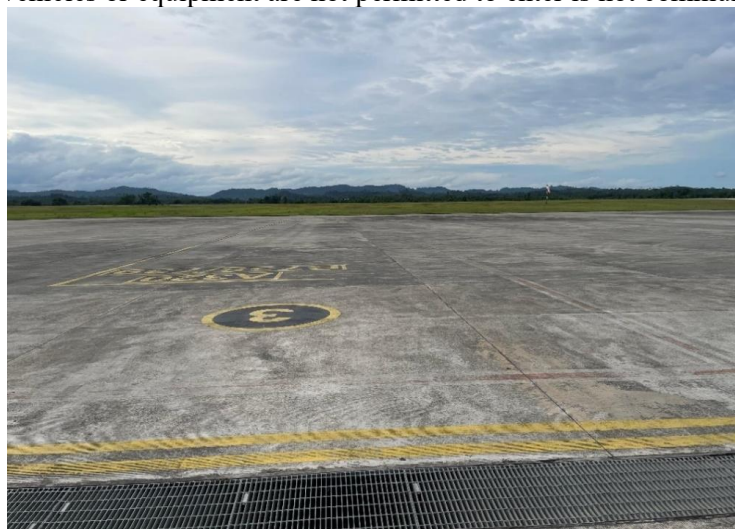
Figure 4 Parking Stand 3 Condition

Based on the author's observations, there are several factors that cause damage or fading of markings on Parking Stands 3, 4, 5, 6, and 7, namely:

- 1) Use of Parking Stands. The more frequently Parking Stands are used, the more intense the traffic of GSE vehicles operating there will be. This causes friction and abrasion from tires, causing markings to fade and gradually become invisible. Additionally, oil spills from GSE vehicles can affect the visibility of airport markings.

- 2) Weather and Temperature Conditions. Weather changes can cause markings to fade. Weather changes from hot to rainy and vice versa cause markings to fade if they are not repainted periodically within a certain time frame. The faded condition of the markings poses potential hazards when providing services to aircraft, including:

- a. Ground handling personnel may misplace equipment because the boundaries on the markings are not visible due to fading, potentially leading to incidents.

- b. The absence of no-parking area markings means that information about boundaries in areas where vehicles or equipment are not permitted to enter is not communicated.

According to ICAO Annex 14, Volume I, Chapter 5: "Markings shall be maintained in a manner that ensures visibility and legibility during both day and night, and under varying weather conditions"[7]. Likewise, PR 21 of 2023, Section 5.3.2, requires: "Markings must be repainted periodically to maintain operational visibility and ensure safety compliance"[6]. The airport authority must conduct repainting of all faded markings using durable thermoplastic paint as recommended in PM 67 of 2018 (Ministry of Transportation)[8]. This includes repainting stop lines, lead-in lines, equipment routes, and no-parking areas. A regular maintenance cycle (every 6–12 months) should be implemented based on apron usage and local climate conditions.
